Report

Project: Waddenzee – LiDAR acquisition
for 2020

Name: Waddenzee – LiDAR acquisition for 2020
Number: 41244
Area: Pinkegat and Zoutkamperlaag in the Wadden Sea, in the north of the Netherlands

Name: Terratec AS
Address: Vækerøveien 3
0281 Oslo
Norway
Project manager: Andreas Velle Wiger
Project number: 10456

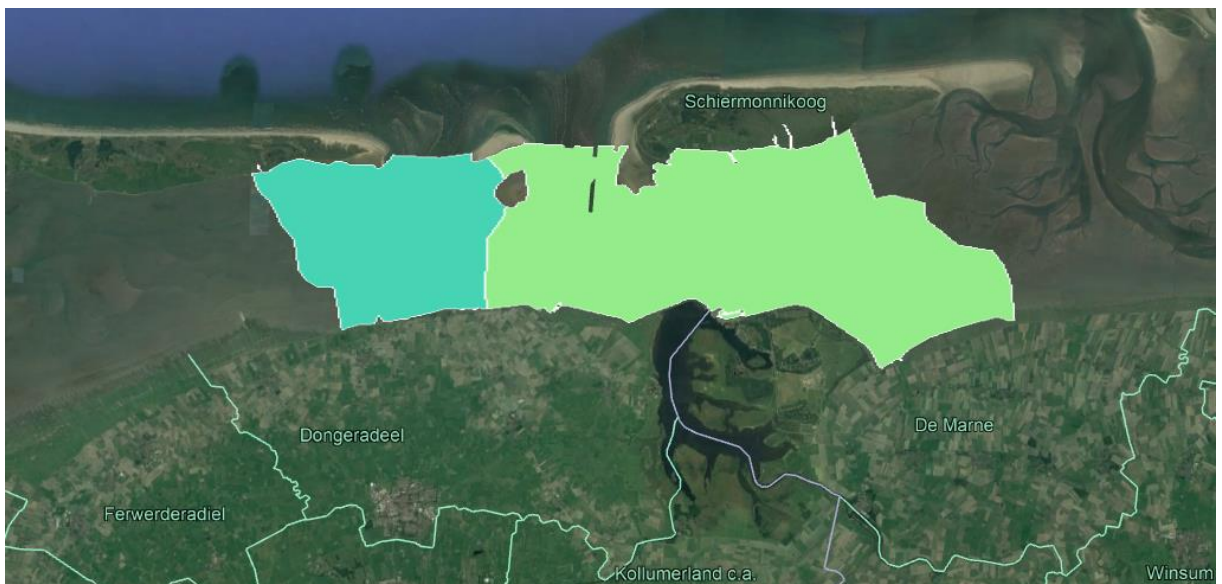
Figure 1: Project area Waddenzee

The figure below shows the location of coverage the 2 areas in the Waddenzee project.

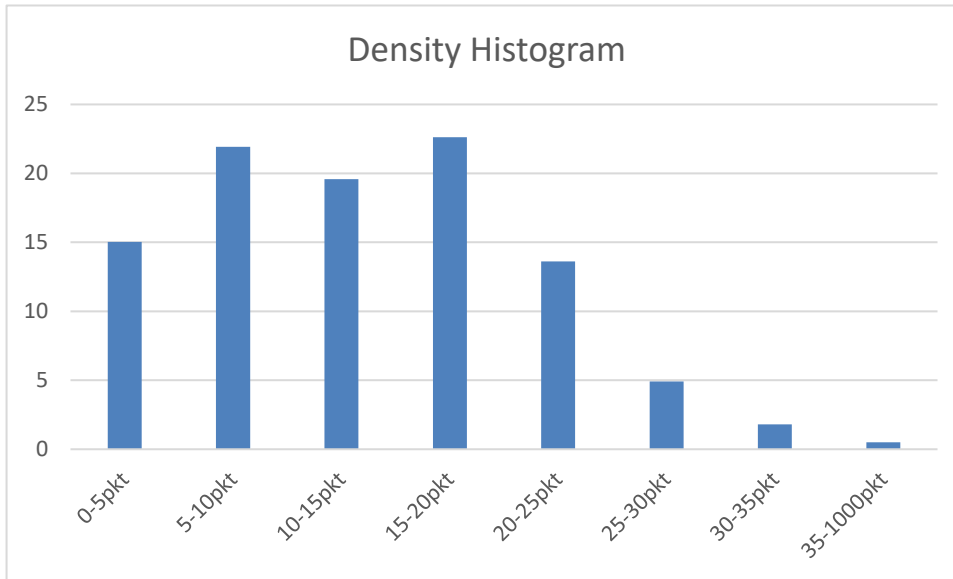
Figure 7: Project density histogram. Y-axis shows percentages of 1x1m tiles with specific density.

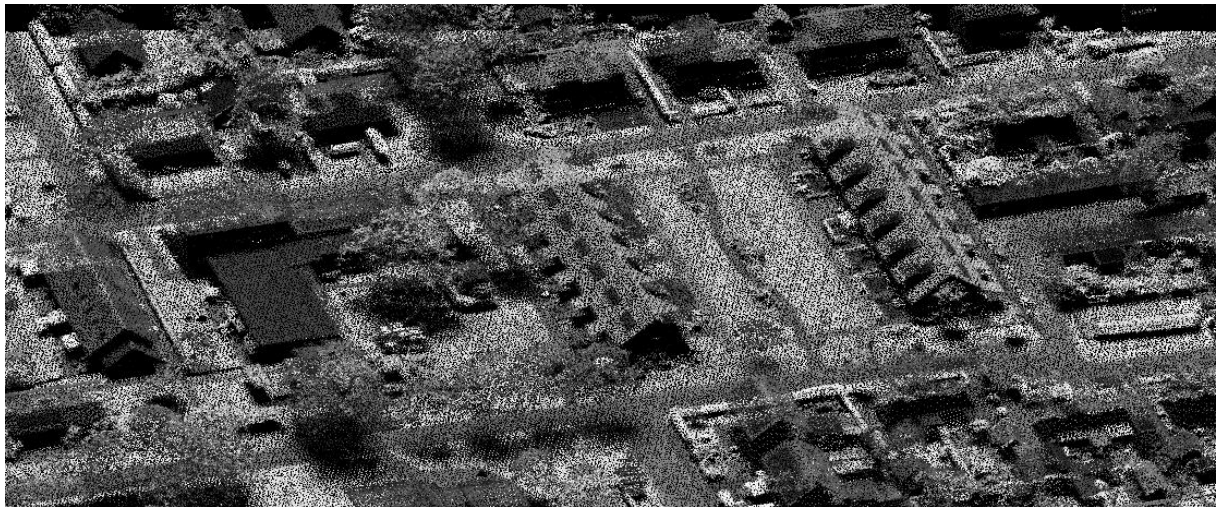
Figure 11: Image shows intensity in cross section / 3D view

The data has been produced with reflectance. Reflectance is amplitude corrected for range – i.e. the effect of amplitude reducing with range of intensity spectrum. This gives intensity values for the same object homogeneous values no matter scan angle returns.
